## Espanola Public Schools

*Carinos del Los Charter School*

### *Loss Control & Safety Audit*

This report contains the findings of an independent Loss Control & Safety Audit of Carinos del Los Charter School. The audit was conducted on March 6, 2014, on behalf of the Espanola Public Schools, and at the request of NMPSIA.

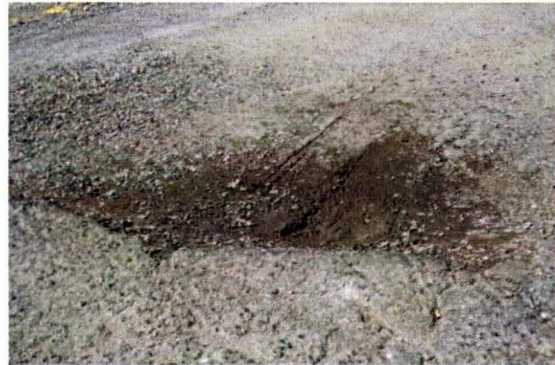
**Recommendation Number: 2014-001**

- Some of the paved areas had minor deterioration that, if left unrepaired, could worsen and result in trip/fall hazards.

- The pavement condition should be closely monitored and repairs made as needed.

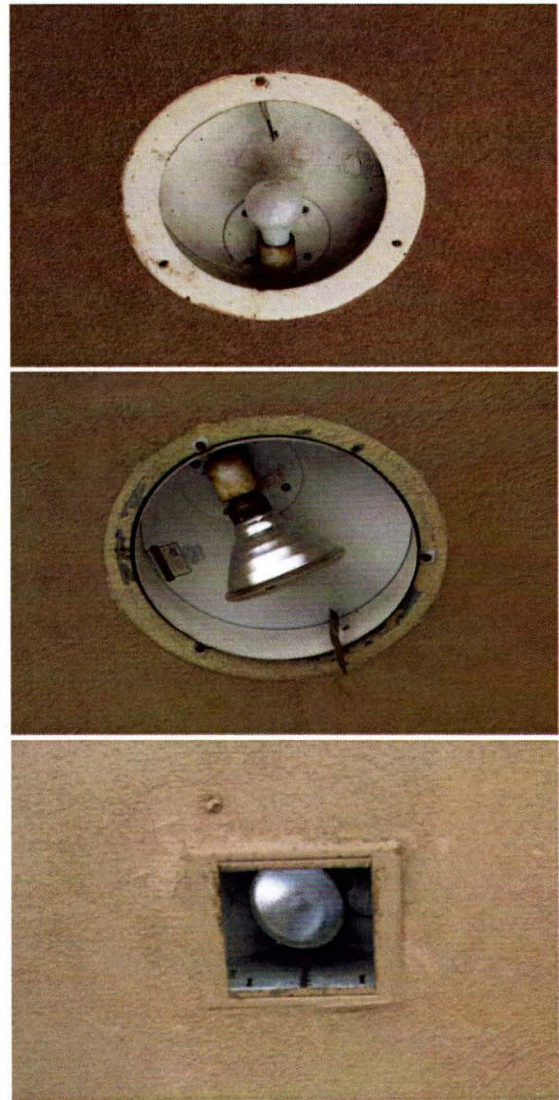
**Recommendation Number: 2014-002**

- Some of the light fixtures were missing diffusers.
- Light diffusers reduce glare, protect the light bulbs from damage, and reduce the hazards created by broken glass should bulbs break.

- Missing light diffusers should be replaced.
- Specially designed plastic sleeves may be used in place of light diffusers for fluorescent light bulbs.

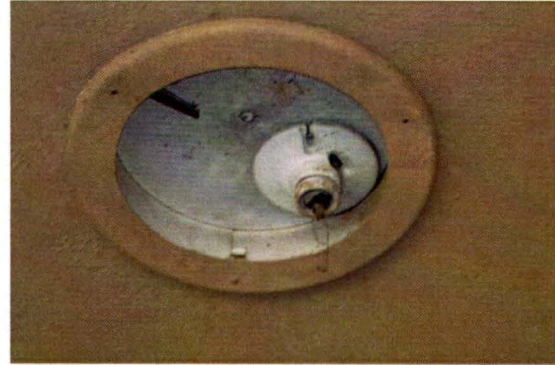
**Recommendation Number: 2014-003****Observations:**

- Exposed light sockets were present where light bulbs were missing.
- The exposed light sockets increase the risks of electric shock and fire incidents.

- Light bulbs should be placed in all open light sockets, or the circuit de-energized, locked and tagged out of service.

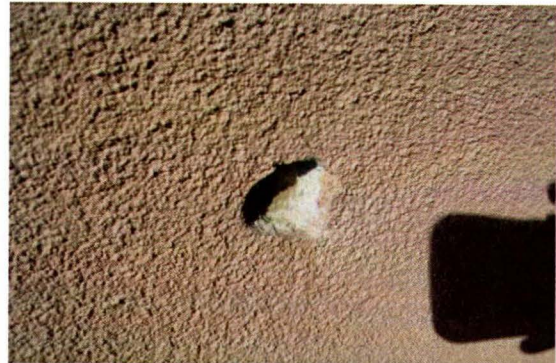
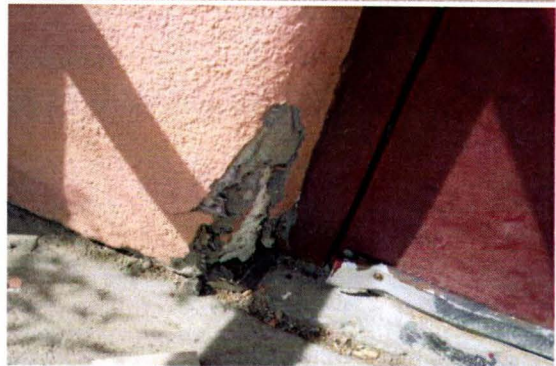
**3. Do building structures and finish materials appear to be in good condition and free of visible deterioration?****Recommendation Number: 2014-004****Observations:**

- The stucco exterior of one or more buildings was damaged.
- The damaged area exposes the building interior structure to the weather elements, and compromises the building's fire safety.

- The damaged areas should be repaired.

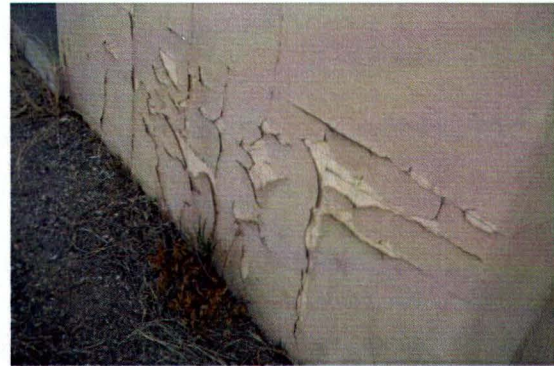
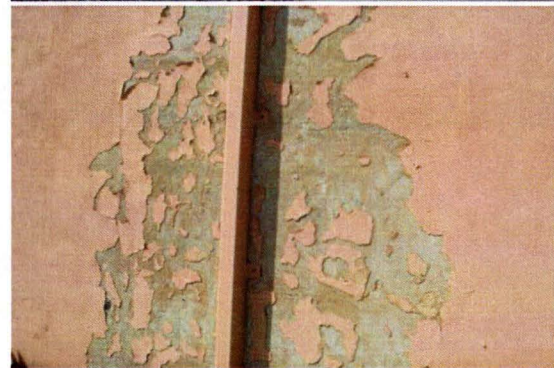
**Recommendation Number: 2014-005****Observations:**

- The paint was peeling in some areas.
- The peeling paint can lead to accelerated building wear and poses an attractive nuisance.

- The peeling and flaking paint should be removed and the surfaces repainted to prevent accelerated building wear.

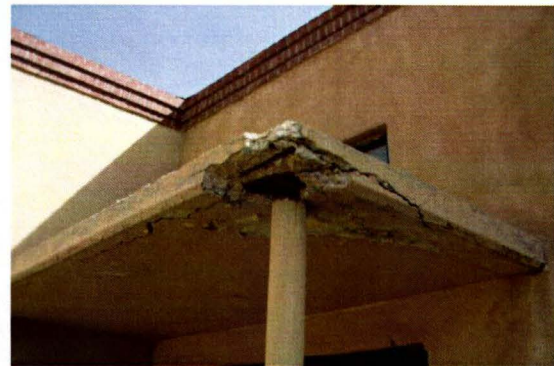
**Recommendation Number: 2014-006****Observations:**

- A concrete entryway cover was deteriorating.

- The cover should be repaired, replaced or removed as necessary.

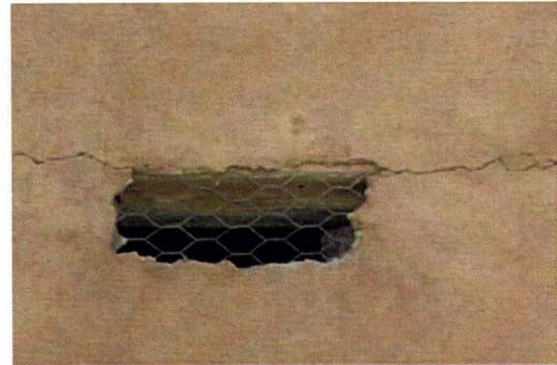
**Recommendation Number: 2014-007****Observations:**

- One or more unguarded ventilation ports were observed.
- The missing port screen/grill permits the entry of disease carrying vermin and other small animals.

- The missing ventilation port guards should be replaced.

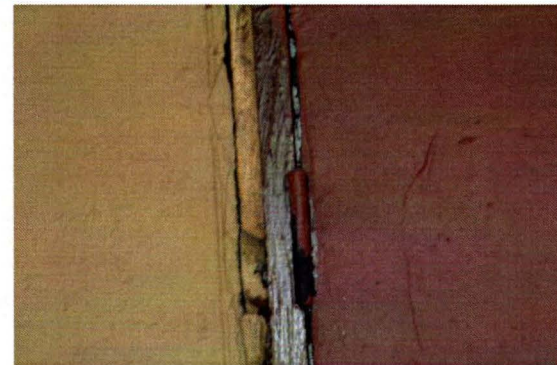
**4. Do doors, windows, and glass appear to be of an appropriate type and condition?****Recommendation Number: 2014-008****Observations:**

- Door frames were damaged and/or deteriorated.

- The damaged door frames should be repaired and/or replaced.
- Door frames should be inspected, repaired and/or replaced on a regular basis to ensure that they function properly and provide adequate security.
- Any construction alterations should be designed and supervised by a person with expertise in building code requirements.

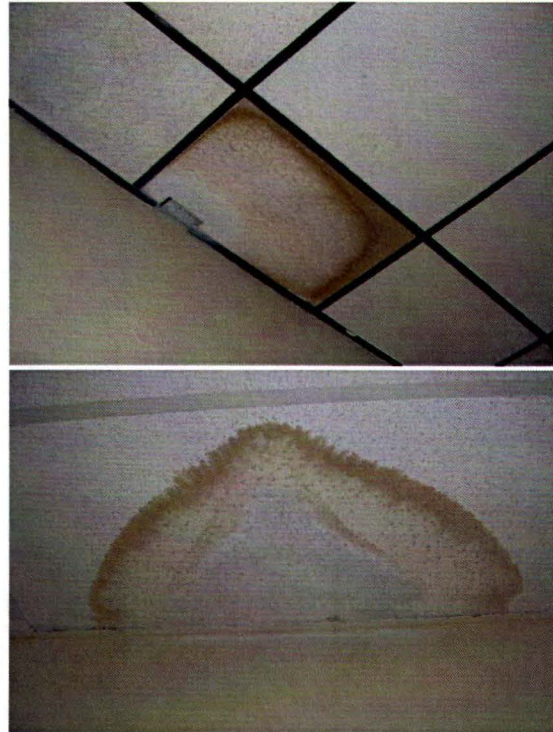
**5. Was the building free of apparent leaks or other obvious water intrusion?****Recommendation Number: 2014-009****Observations:**

- Evidence of leaks and/or other water intrusion was present.
- Water intrusion and the presence of moisture in building materials can foster the growth of mold and mildew.

- The source of the water intrusion should be determined and corrective action taken to prevent recurrence.
- Wall coverings, ceiling tiles, floor coverings, and wall and ceiling insulation should be inspected to identify the presence of damage or mold growth. Both exposed and concealed surfaces should be inspected.
- Damaged and contaminated materials should be removed and disposed of in a way that prevents their continued use.
- The entire damaged or contaminated area should be cleaned and disinfected with an effective fungicide prior to installing new materials.

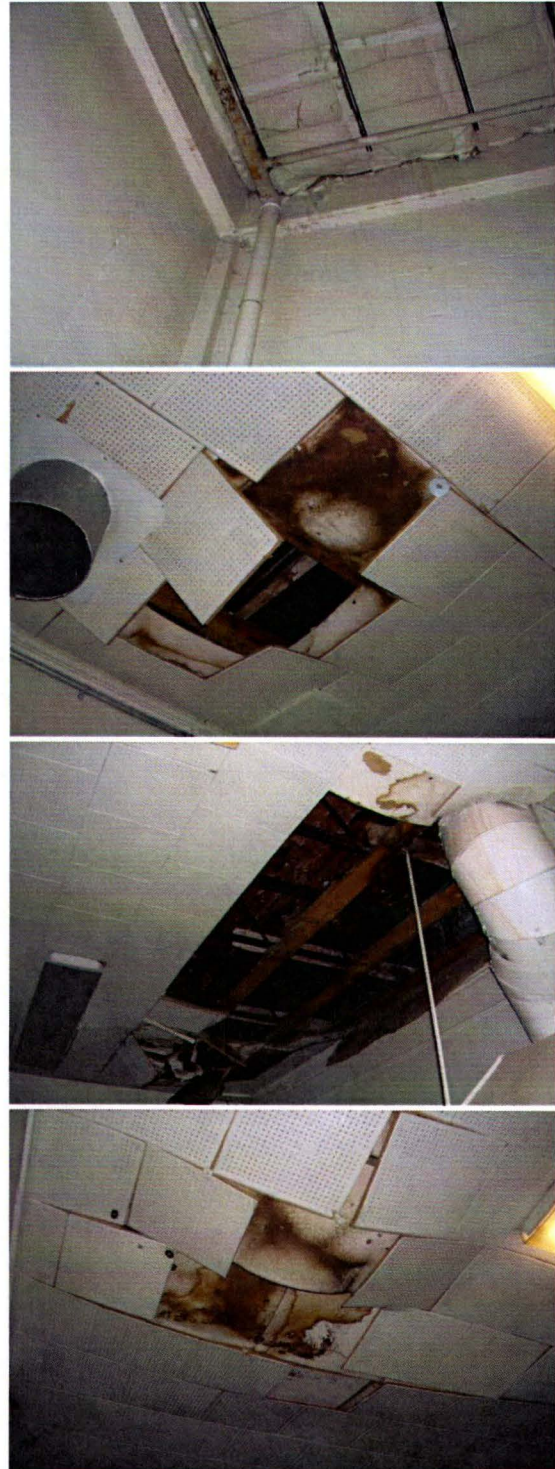
**Recommendation Number: 2014-010****Observations:**

- Evidence of a leak was observed that may be an indication of structural damage.

- A structural or civil engineer should inspect the building to determine the extent of the damage, assess any risks related to continued use of the building and recommend corrective action.
- Corrective action should address repair of the current damage and measures necessary to reduce recurrence of this condition.

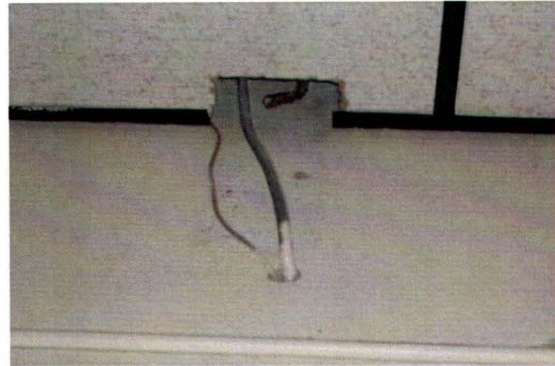
**6. Do walls and ceilings appear to be of an appropriate type and condition?****Recommendation Number: 2014-011****Observations:**

- Annular openings were observed in the ceilings.
- The annular openings were not fire stopped.
- The annular openings in the ceilings compromise the fire safety of the structure, and they provide an entry point for insects and vermin.

- The annular openings in the ceilings should be properly fire stopped.

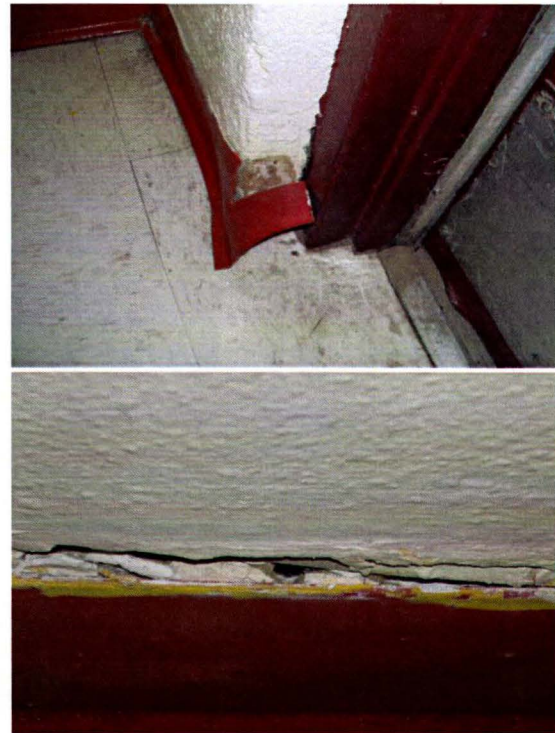
**Recommendation Number: 2014-012****Observations:**

- Some of the baseboard molding observed was loose.
- This condition poses trip/fall hazards.

- The loose molding should be securely fastened to the wall.

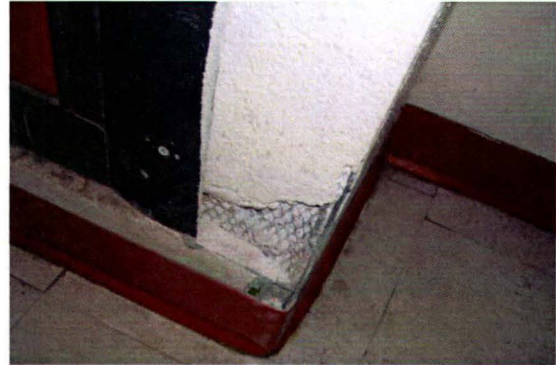
**Recommendation Number: 2014-013****Observations:**

- The wall covering observed in one or more areas was damaged and/or peeling.
- The damaged areas pose an attractive nuisance and invite more damage.

- Any damage to the walls or wall coverings should be repaired.

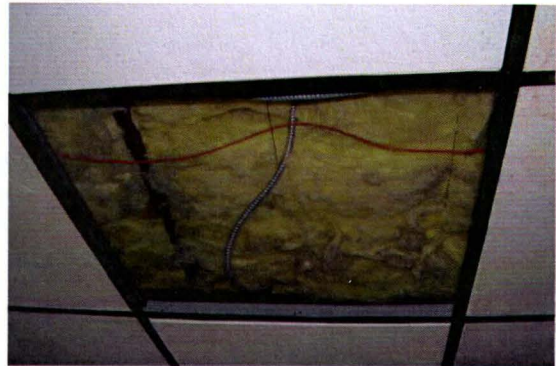
**Recommendation Number: 2014-014****Observations:**

- Ceiling tiles were missing, and insulation material was exposed.
- These conditions could result in respiratory and skin irritations, compromise the building's fire safety, and pose an attractive nuisance.

- The missing ceiling tiles should be replaced.

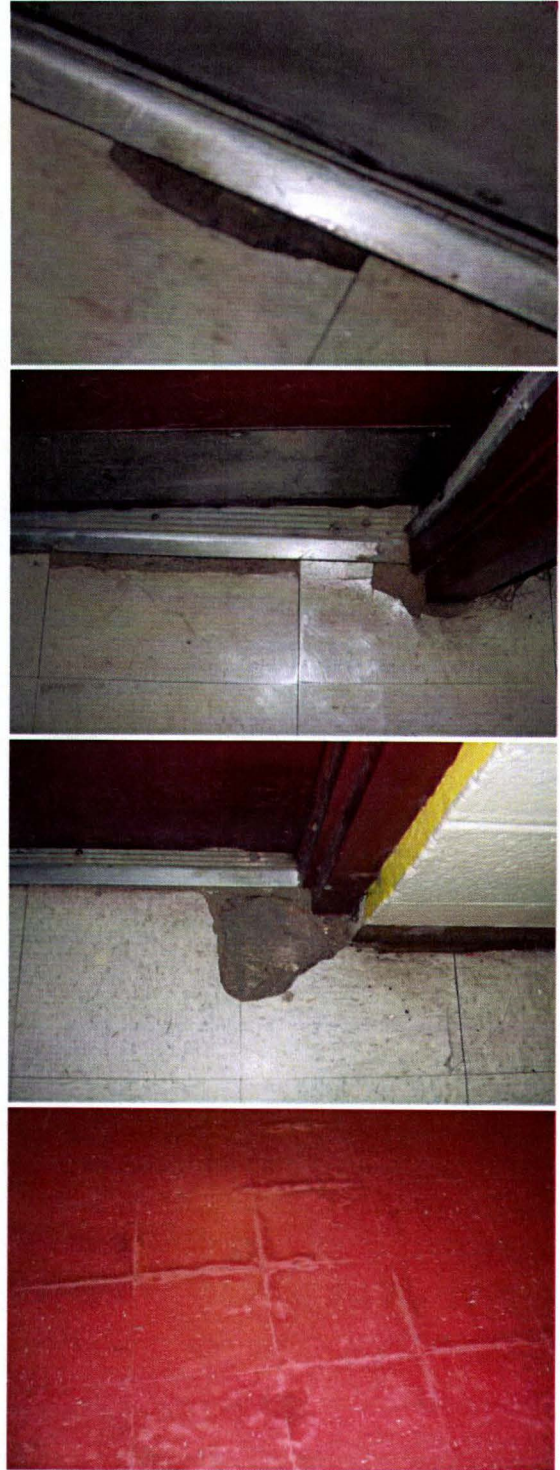
**7. Are floors and floor coverings of an appropriate type and condition?****Recommendation Number: 2014-015****Observations:**

- Some of the floor tiles were damaged.
- The damaged flooring presents slip/trip/fall hazards.
- Some of the damaged floor tiles or their adhesive may contain asbestos, which could present an asbestos exposure hazard.

- The site Asbestos Management Plan should be reviewed to determine if the flooring contains asbestos.
- Damaged flooring that does not contain asbestos should be removed and replaced.
- Damaged flooring that contains asbestos should be abated in accordance with AHERA requirements.
- Missing and damaged floor tiles should be repaired and/or replaced to reduce trip/fall hazards.

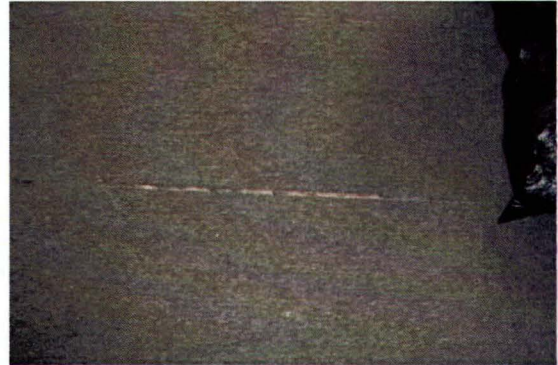
**Recommendation Number: 2014-016****Observations:**

- The carpeting was frayed and unraveling in places.
- The loose threads of the unraveling carpeting pose trip/fall hazards.

- The manufacturer of the carpeting should be contacted to determine the best methods to repair the carpeting.
- The carpeting should be repaired or replaced in accordance with the manufacturer's recommendations.
- The manufacturer should also be asked what installation steps should be taken to avoid this condition in the future.

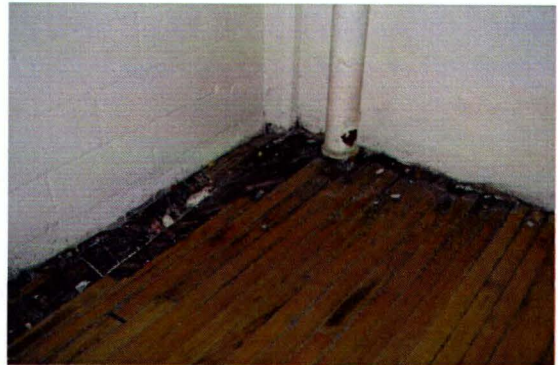
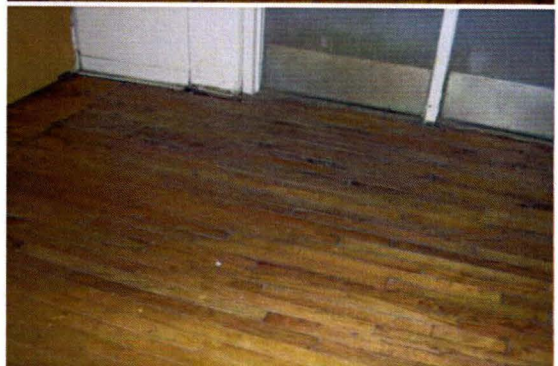
**Recommendation Number: 2014-017****Observations:**

- Some of the floor boards in the gym were water damaged.
- The damaged flooring presents slip/trip/fall hazards.

- Missing and damaged floor boards should be repaired and/or replaced to reduce trip/fall hazards.

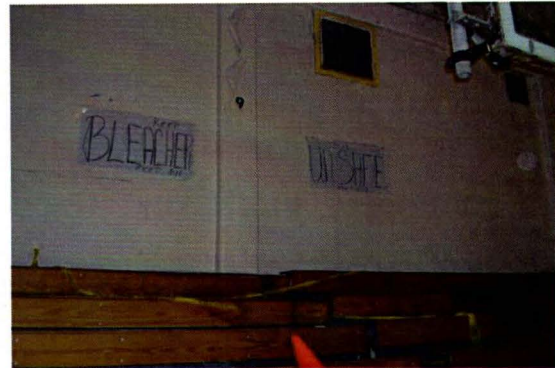
**Recommendation Number: 2014-018**

- Signs were posting indicating safety problem with bleachers.
- Bleacher structures and grandstands present a loss exposure due to falls and/or structure failure.

- A preventive maintenance program should be administered for telescoping and/or folding bleachers.
- The program should include a comprehensive annual inspection by a qualified person and biennial inspections by a professional engineer, registered architect, or other qualified individual certified by the bleacher manufacturer.
- Documentation of inspections and repairs should be maintained.
- The wheels, connecting components, and locking mechanisms of these tables should be thoroughly inspected on a regular basis, at minimum annually.
- The wheels should be cleaned and the connecting and locking components replaced when they begin to show signs of wear.
- The wheels and pivot points should be kept lubricated as recommended by the manufacturer to reduce the wear on the components.

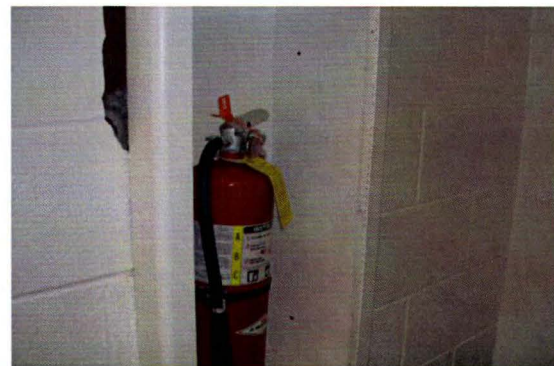
**Recommendation Number: 2014-020**

- The access window of one of the fire extinguisher cabinets was observed to be missing.

- The windows in the fire response cabinets should be replaced with breakable material.

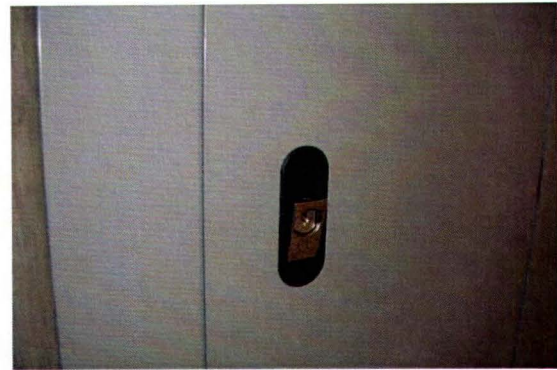
**Recommendation Number: 2014-023****Observations:**

- One or more electric panelboards that were accessible to unauthorized persons were unlocked.
- This permits unauthorized access to the circuit breakers.

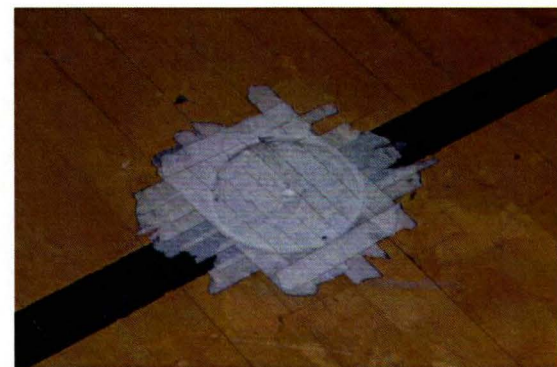
**12. Are electrical fixtures properly installed, properly protected, and free of damage?****Recommendation Number: 2014-024****Observations:**

- Tape was placed over an electric receptacle.
- This practice poses fire hazards.

- The practice of taping receptacles should be discontinued.
- The situation should be investigated to determine why the receptacle is taped.
- If it is taped to prevent water or dust from entering, the receptacle should be replaced with a ground fault circuit interrupter equipped receptacle that is also equipped with a weather resistant, spring-loaded cover.
- If it is taped to prevent overloading the circuit, a qualified electrician should inspect the circuit to determine what changes should be made to repair the circuit.
- If it is taped because the circuit is damaged, then the circuit should be properly repaired by qualified personnel.

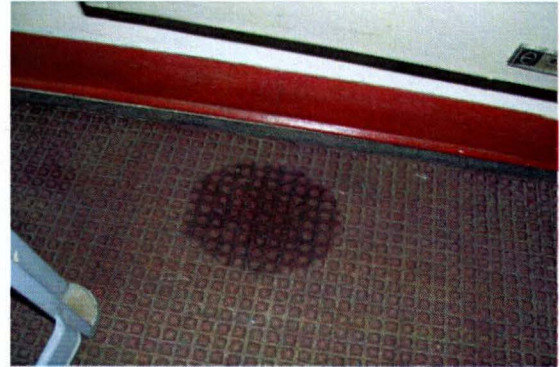
**Recommendation Number: 2014-025**

- One or more leaking water fountains were observed.

- The leaking plumbing should be repaired.

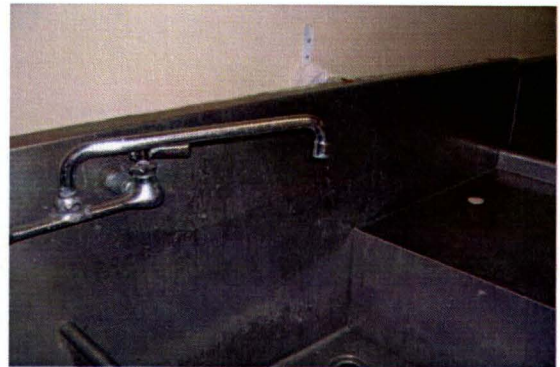
**Recommendation Number: 2014-026**

- A leaking sink was observed.

- The leaking plumbing should be repaired.

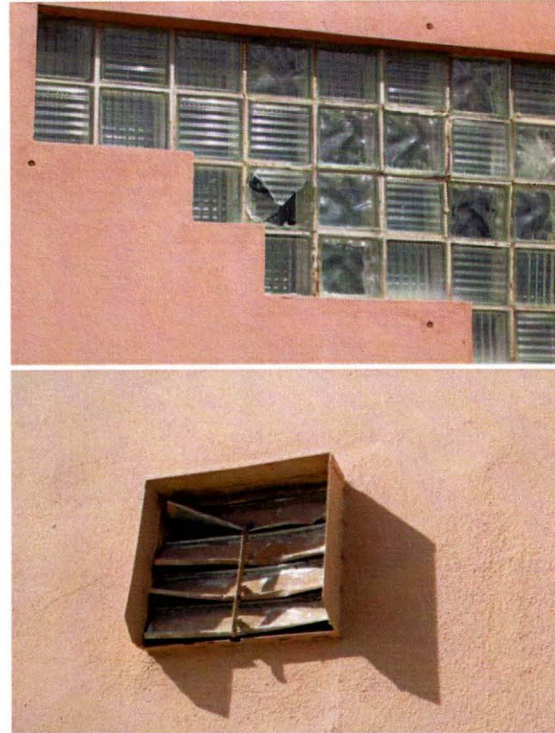
**Recommendation Number: 2014-029****Observations:**

- In addition to graffiti, other evidence of vandalism was observed, such as damaged windows and vents.
- The damaged property posed injury hazards, and encouraged additional acts of vandalism.

- The damaged property should be repaired.
- Consideration should be given to reviewing the patterns of vandalism, such as the time of the year, days of the week, time of day, and areas of the property where vandalism occurs. Then a targeted prevention plan should be developed and implemented.

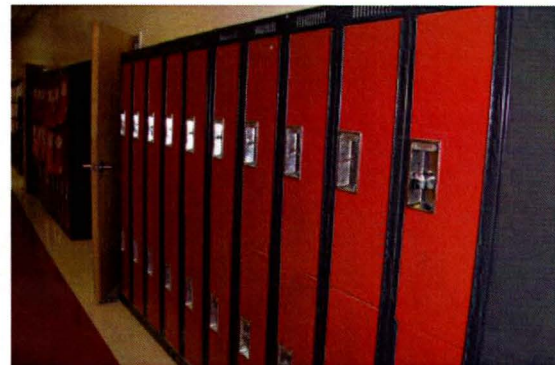
**16. Are other general conditions free of apparent hazards or concerns?****Recommendation Number: 2014-030****Observations:**

- Student lockers were present but not in use. Eliminating student lockers may reduce vandalism, contraband, and harassment incidents.

- Consideration should be given to removing the lockers.
- If the District chooses to retain the lockers, any damaged lockers should be repaired or replaced.
- If lockers are retained and used, they should be assigned by grade level to reduce the likelihood of harassment between grade levels.

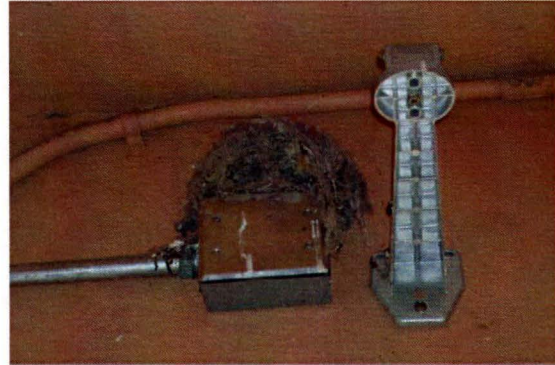
**Recommendation Number: 2014-031****Observations:**

- Bird nests were observed in the exterior lights, building structures, and/or exterior utility structures.
- The bird nests can pose fire, health, and property damage hazards.

- Bird nests, bird droppings, and any other debris should be removed.
- Bird droppings should be cleaned using the appropriate personal protective equipment and disposed of as potentially infectious material.
- Holes and/or openings in which birds roost should be treated or sealed off to prevent the birds from nesting.

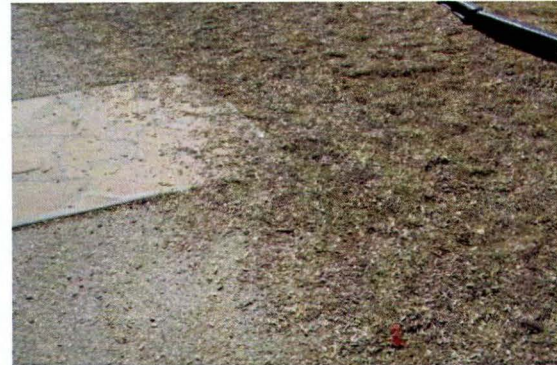
**Recommendation Number: 2014-033**

- The protective surfacing had become displaced from the intended area onto the adjacent sidewalk.
- This condition poses numerous slip/fall hazards.

- The protective surfacing should be swept back into the designated play area on a daily basis.
